**GREAT LAKES INDIAN FISH AND WILDLIFE COMMISSION**  
**P. O. Box 9 • Odanah, WI 54861 • 715/682-6619 • FAX 715/682-9294**

Technical Memorandum

Re: Water Quality observations at Twin Lakes, US Steel site, June & August 2017

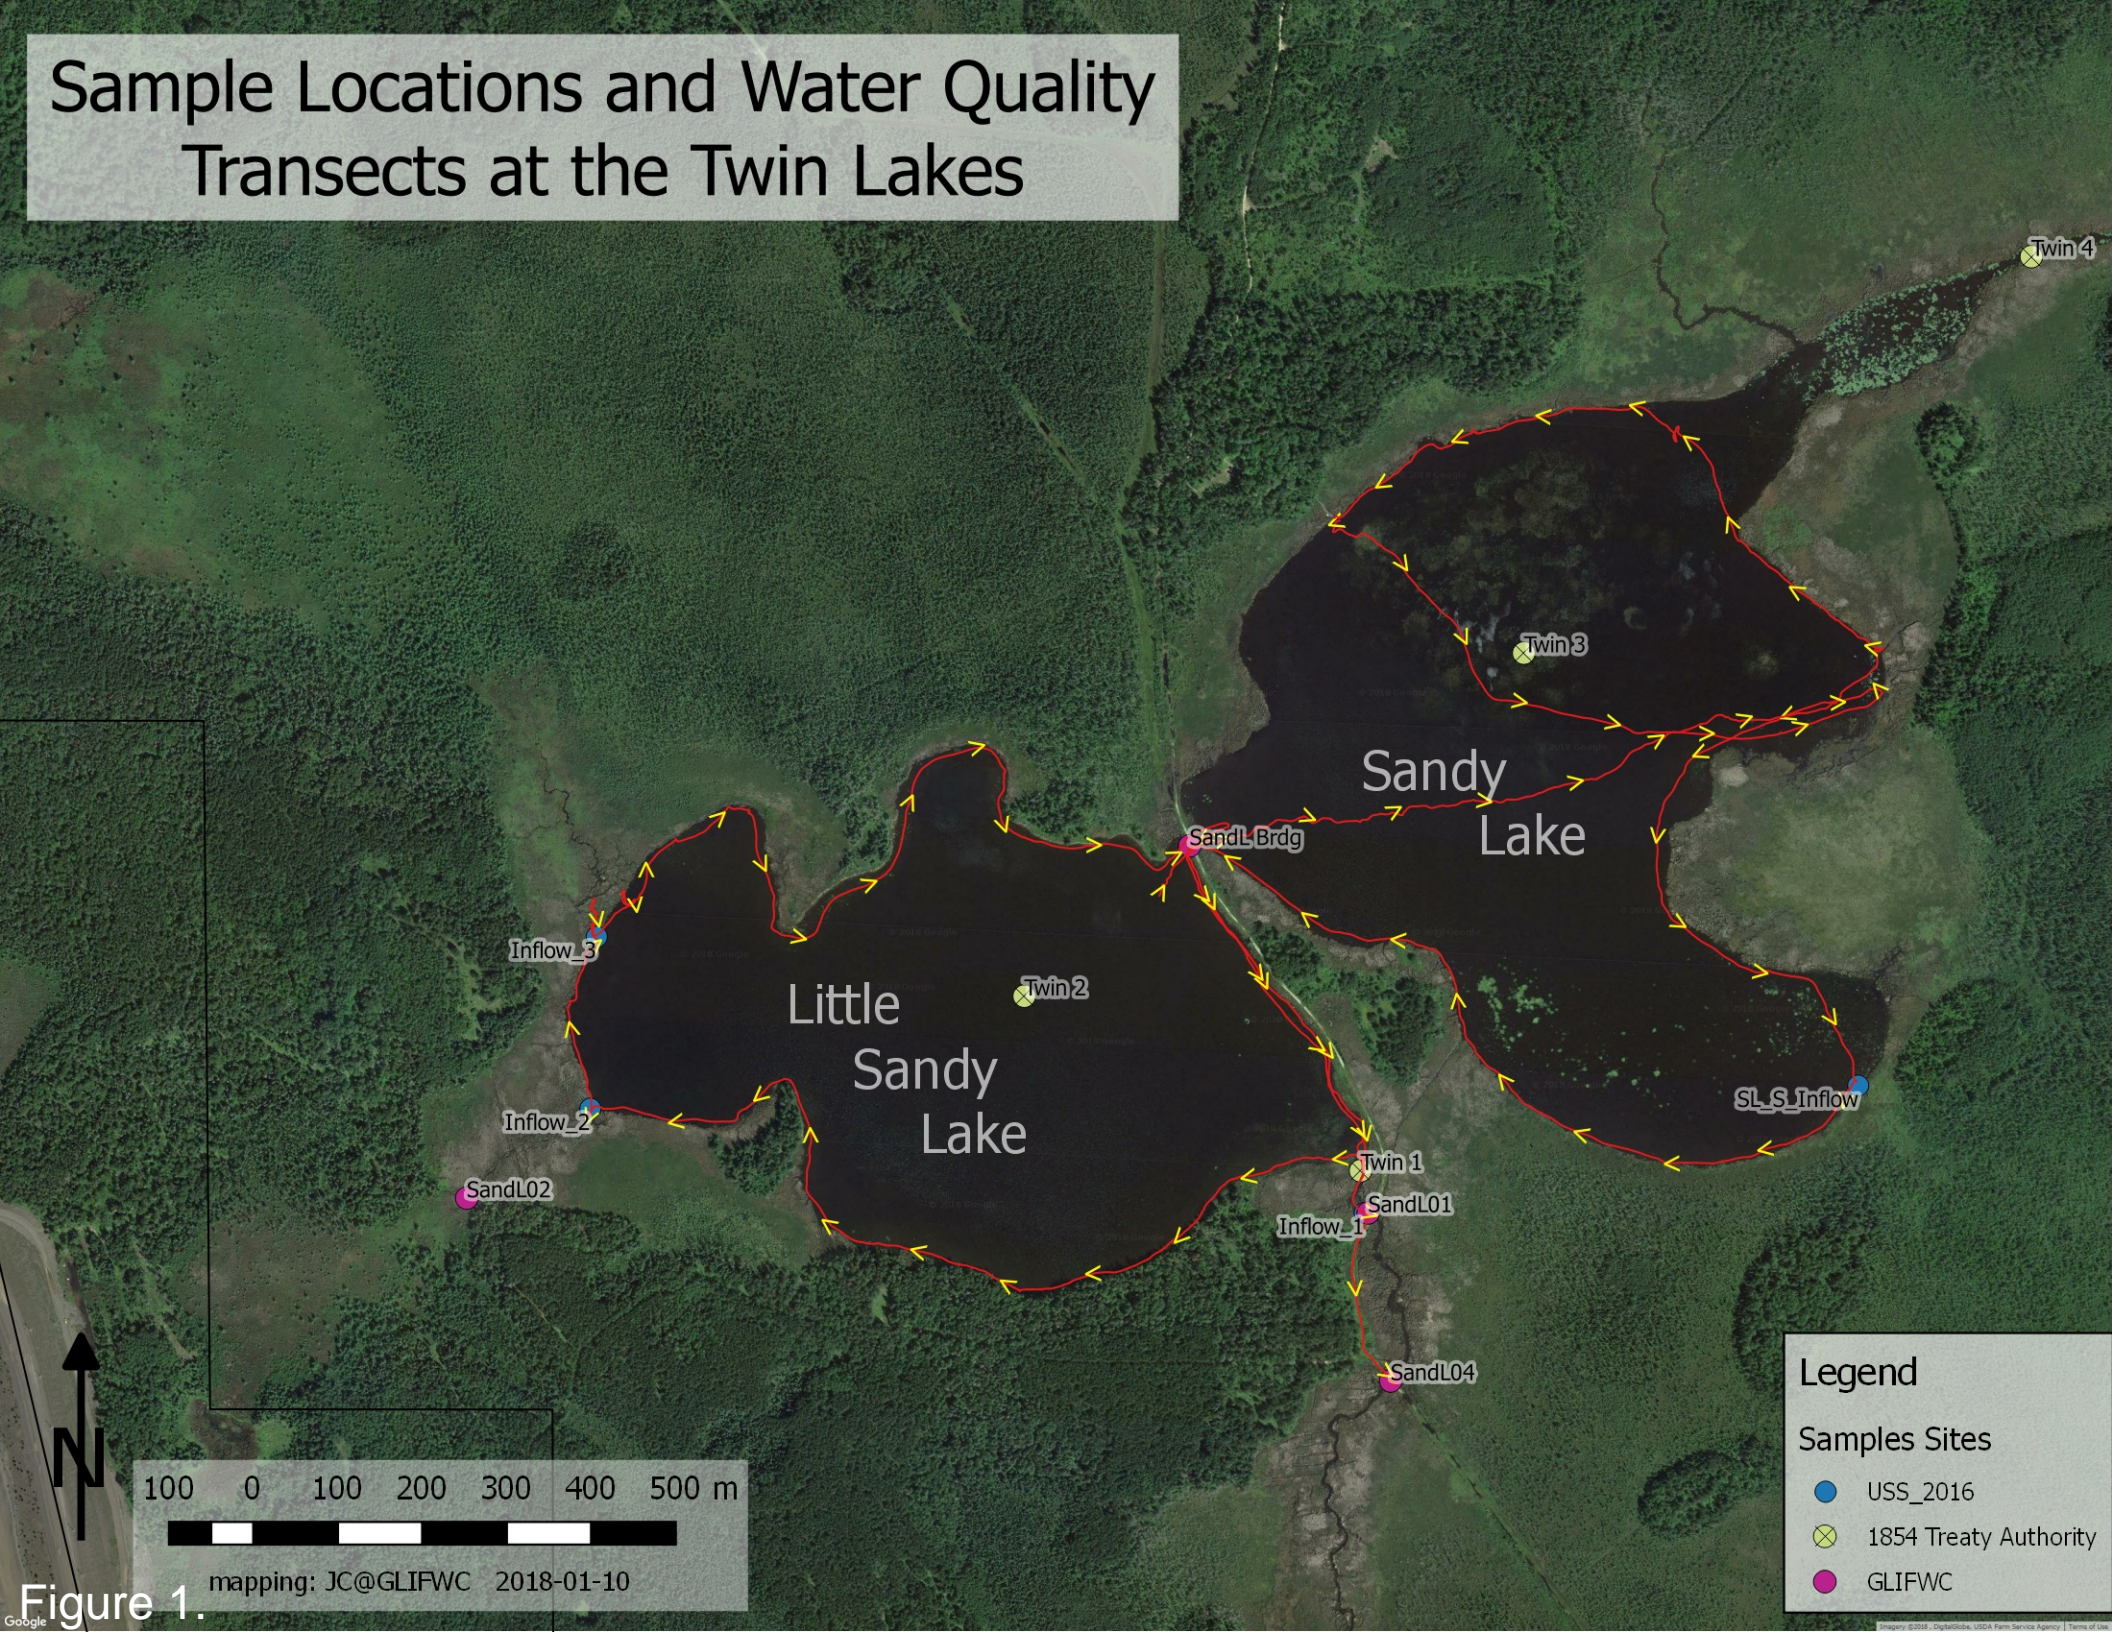
# Sample Locations and Water Quality Transects at the Twin Lakes

Surface water quality grab samples were collected at select locations (Figure 1) and samples submitted for analysis at the University of Wisconsin Stevens Point WEAL lab. A sample duplicate was collected at one sample site and submitted to the Northern Lake Service Lab in Crandon, Wisconsin.

A YSI ProDSS water quality meter was used to collect spot measurements of 6 parameters, Specific Conductance (i.e. conductivity@25Deg.C), pH, Chloride<sup>1</sup>, Dissolved Oxygen, Temperature and Depth. Sample sites are indicated in Figure 1. At two sites, field measurements were recorded once after parameter readings stabilized. At 5 sites, in-lake measurements were recorded from canoe at 10 second intervals for 1 to 5 minutes and the readings averaged.

Lakewide surveys, were conducted by canoe, primarily along the shoreline of Little Sandy and Sandy Lakes for the six parameters collected by the YSI ProDSS. The path of the transects is shown in Figure 1. The YSI ProDSS sensors were pulled behind the canoe at 0 to 2.5 miles per hour. Readings were recorded every 10 seconds and locations of the readings were recorded with the meter's internal GPS sensor. Depth of the readings were between 3 and 83 cm and averaged 29 cm. Depth was recorded by the meter's internal depth sensor. Speed of the canoe as it traversed the transects was calculated from the time and locational data collected by the YSI meter. Inlets to the Twin Lakes that had been previously identified from aerial photographs were investigated and field parameters measures at the mouth of the inlets.

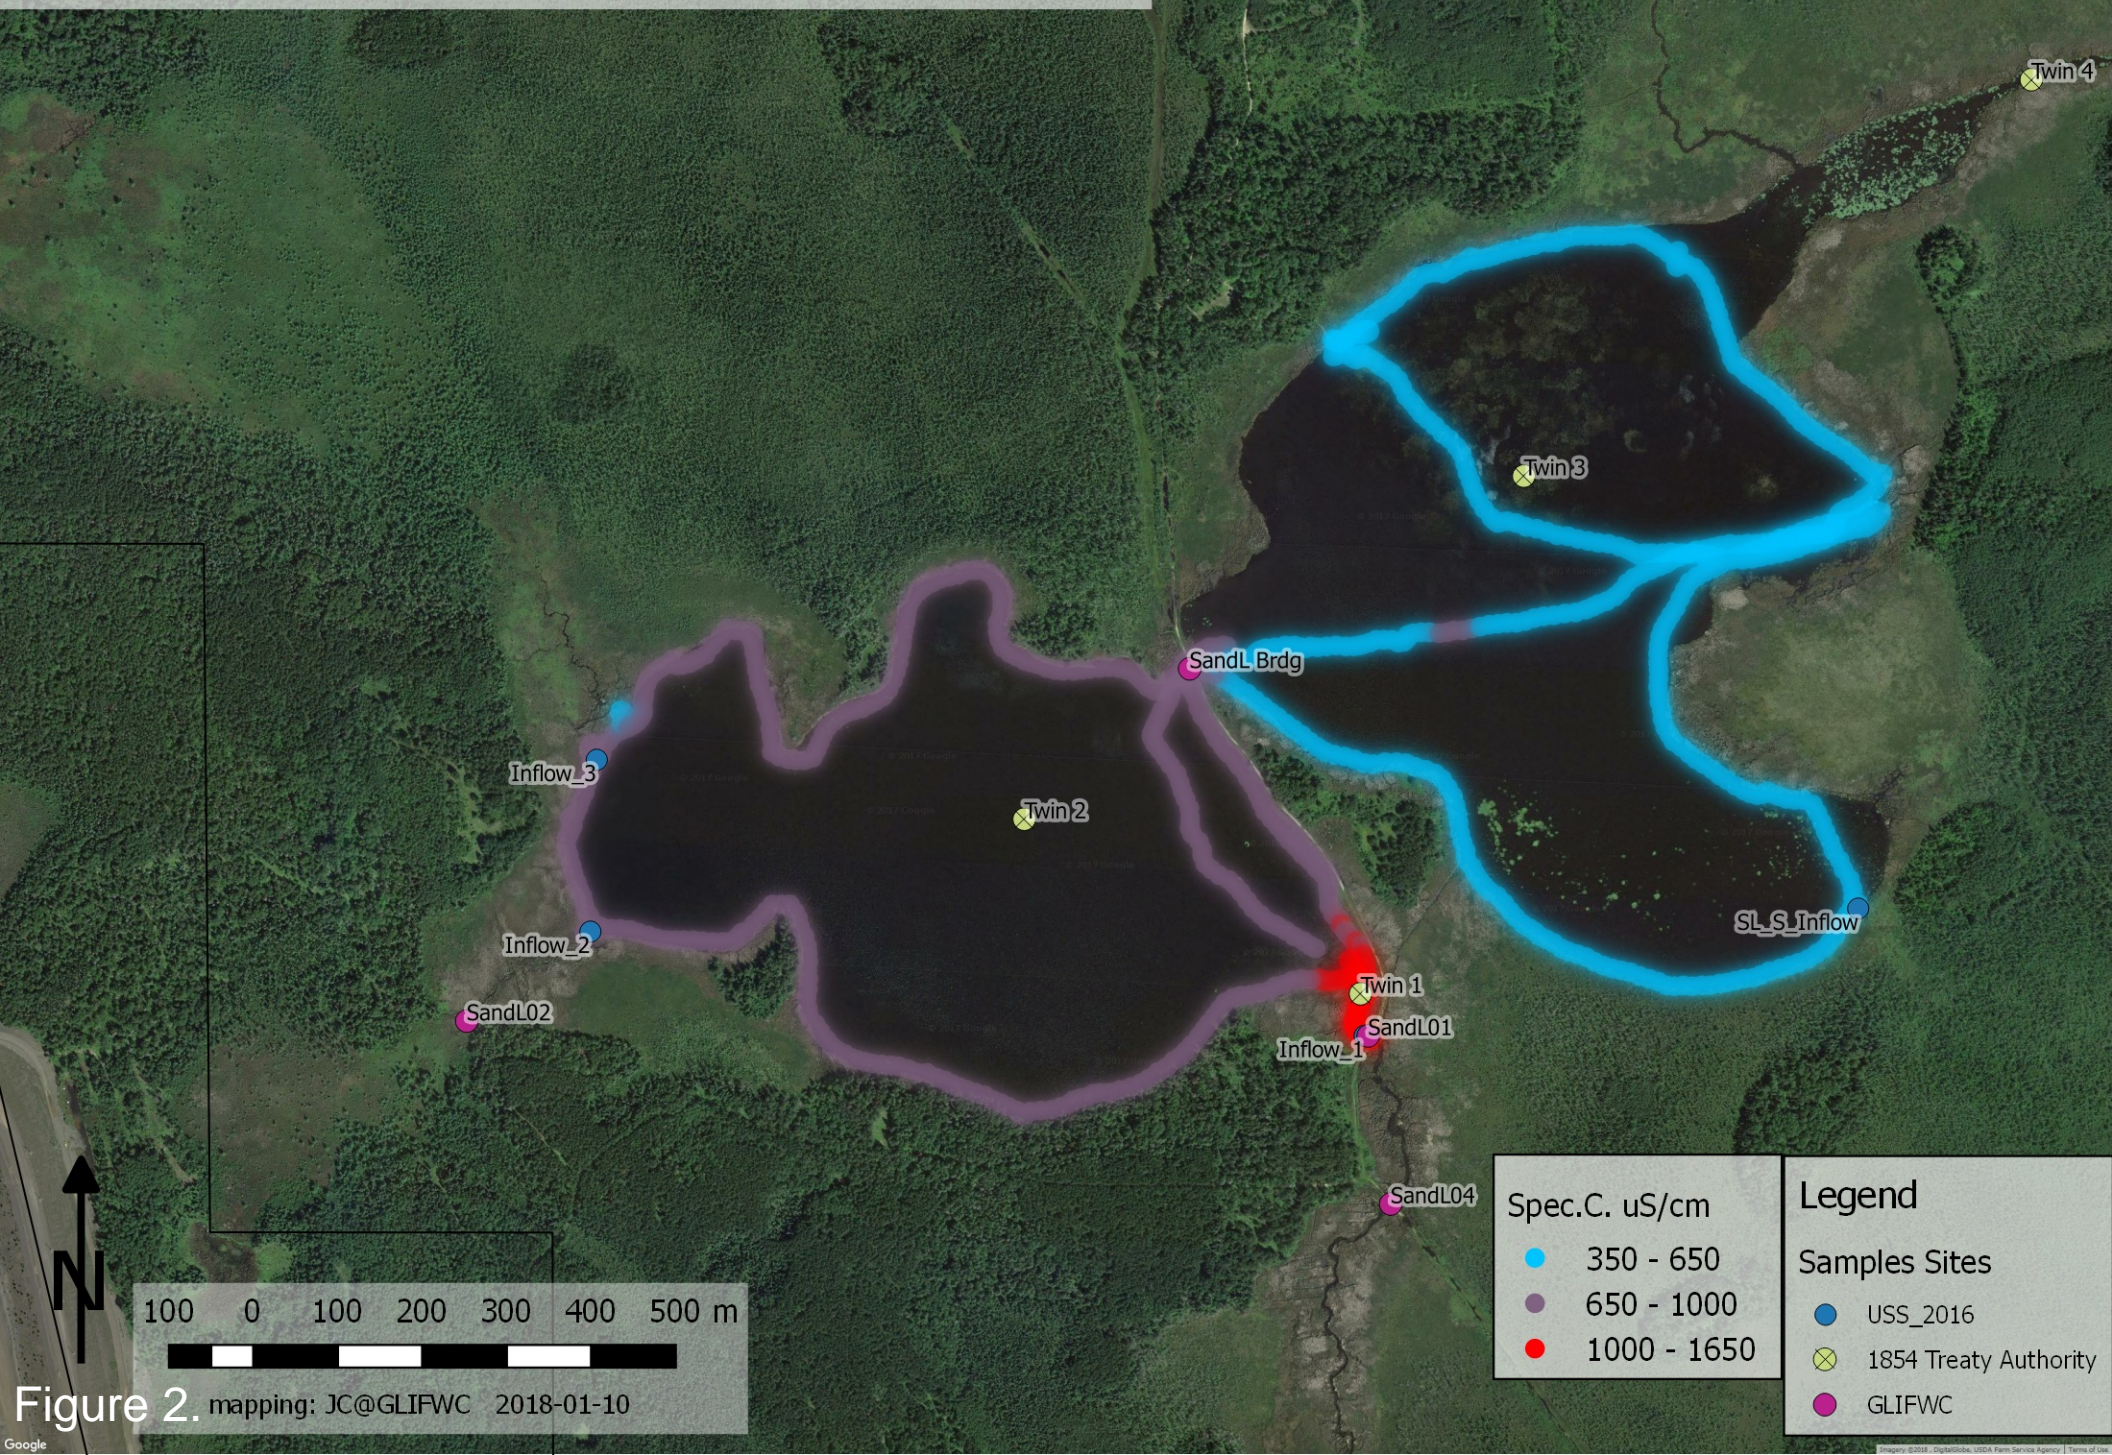
Figure 2. mapping: JC@GLIFWC 2018-01-10

Specific Conductance.- Specific Conductance (Figure 2), and by extrapolation total dissolved solids (TDS) was substantially higher in the upper lake (Little Sandy Lake) and substantially lower once one moved through the isthmus into Sandy Lake. It appears likely that unpolluted inputs from the watershed to Sandy Lake serve to dilute the high concentrations contributed by Little Sand Lake. Specific Conductance was approximately 2-fold higher near the Twin-1 inlet than elsewhere in Little Sandy Lake and approximately 3-fold higher than in Sandy Lake. Specific Conductance at Inflow\_3 was substantially lower than observed elsewhere in Little Sandy Lake.

# Specific Conductance Transects at the Twin Lakes

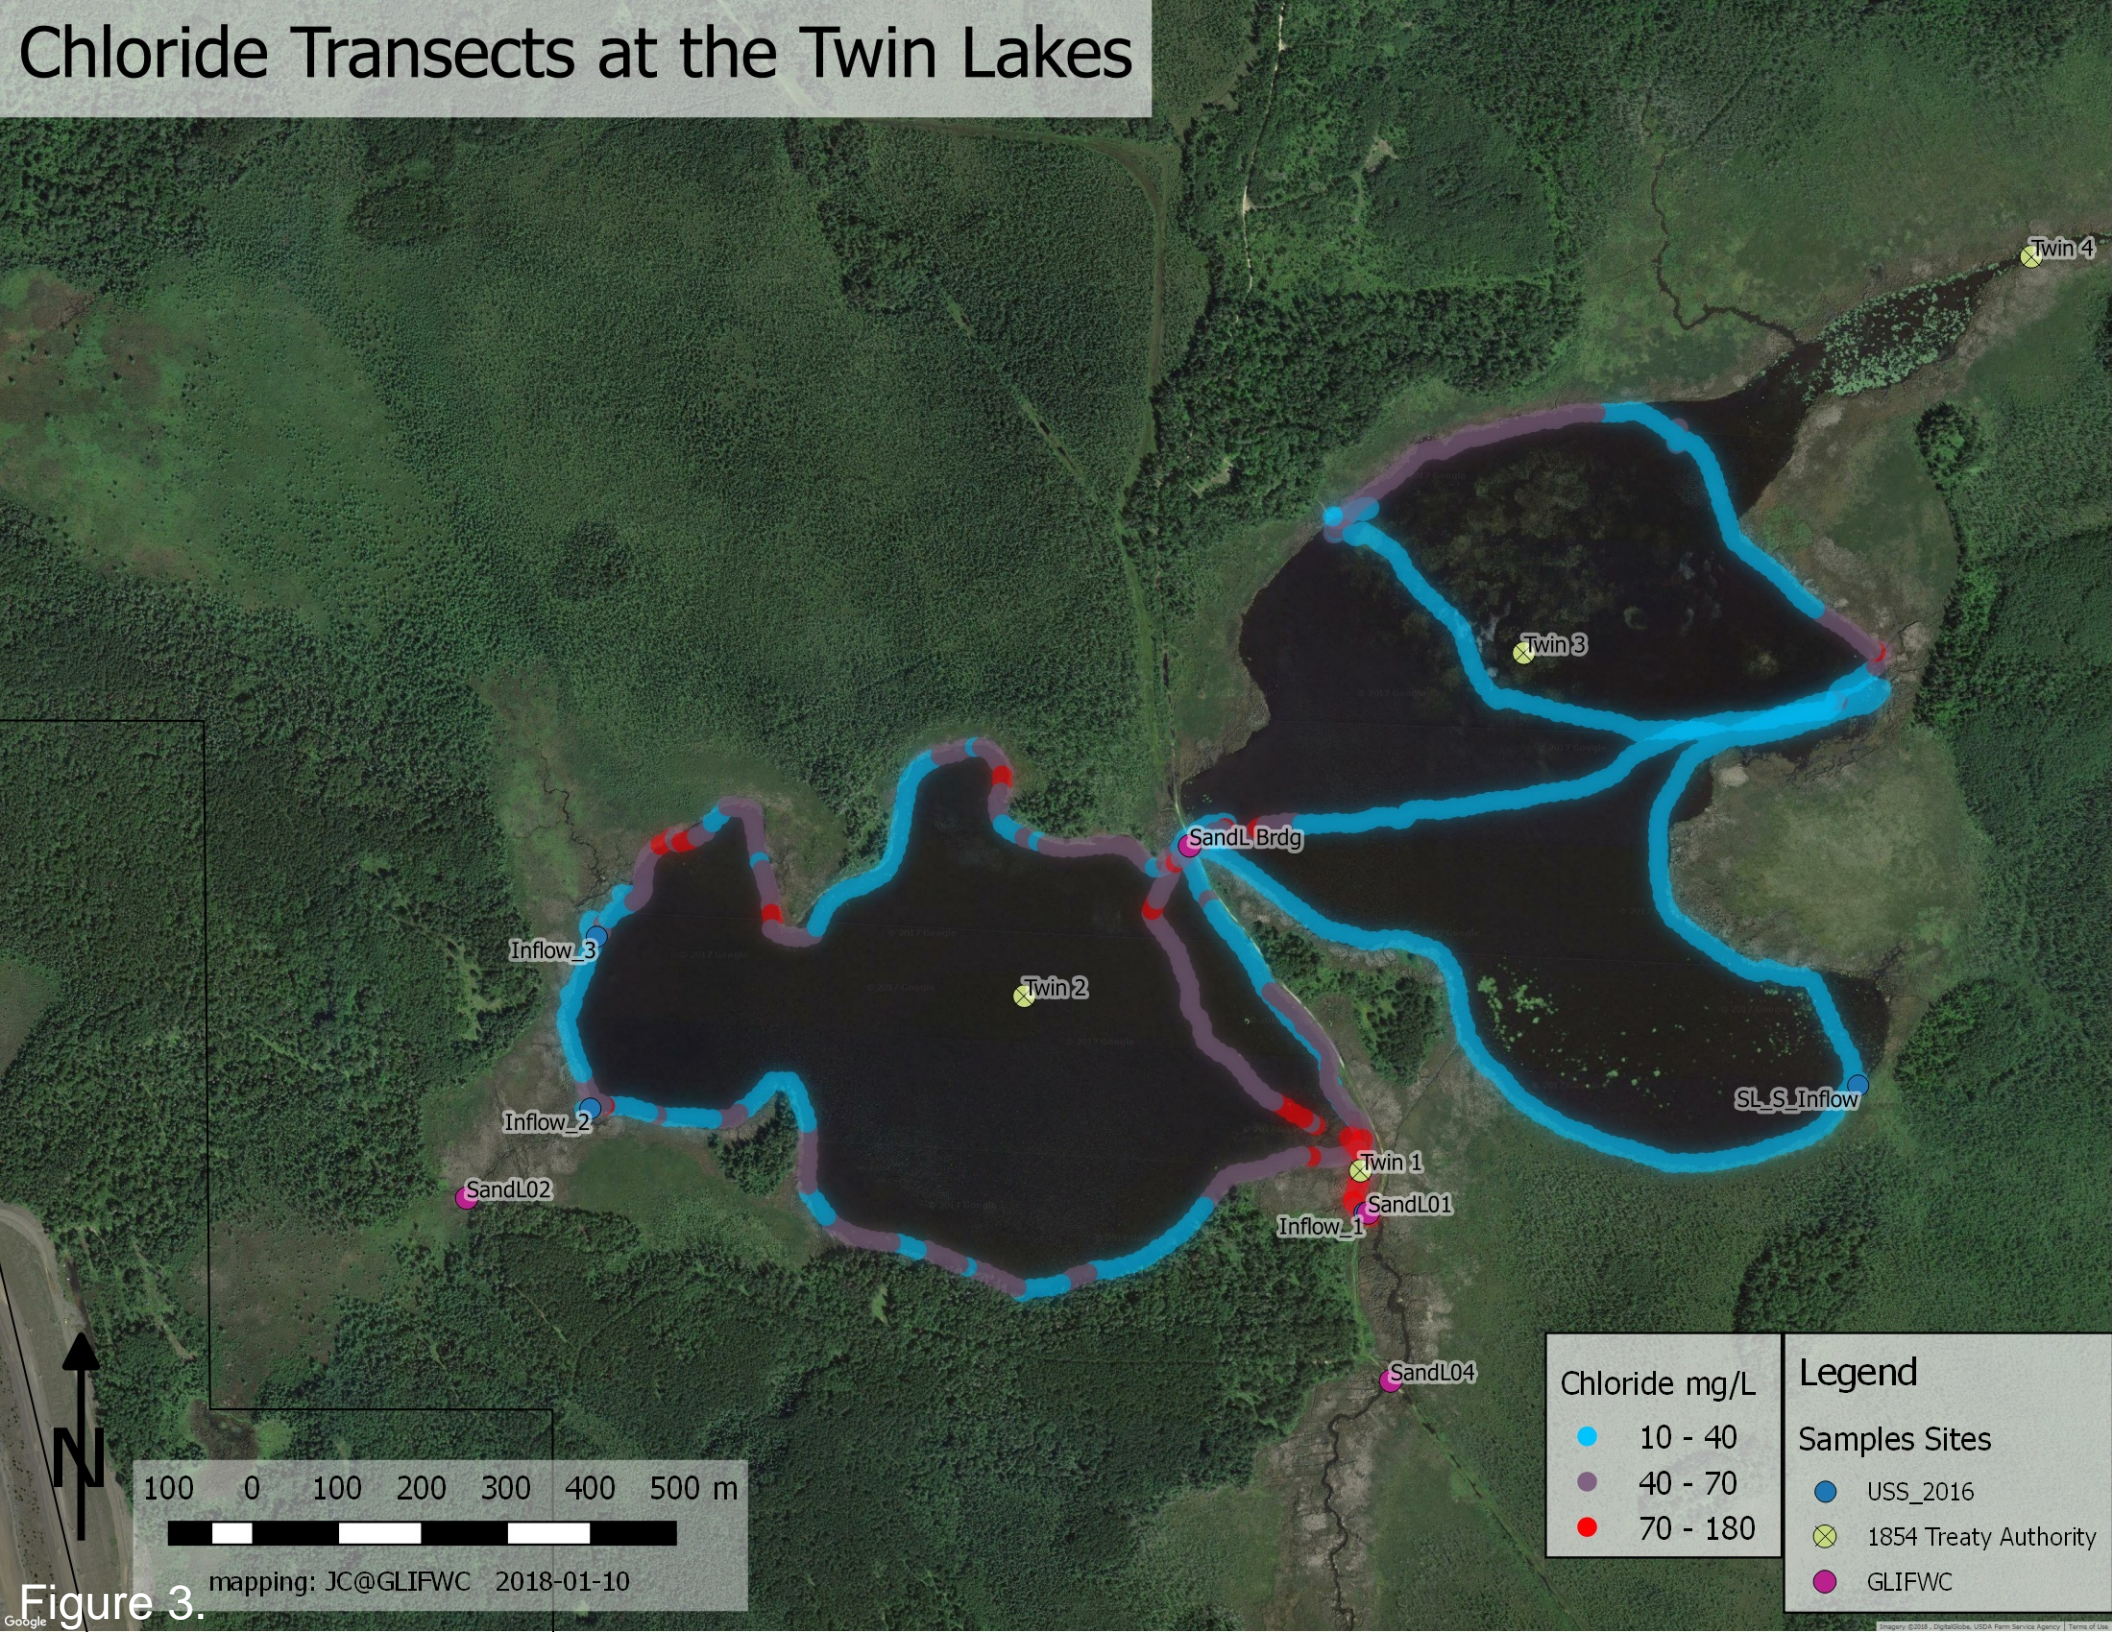
Figure 3.

Chloride.- Chloride levels (Figure 3) in the lakes varied in a way similar to that observed in Specific Conductance. The highest values (> 70 mg/L Cl<sup>-</sup>) were observed at the inlet to Little Sandy Lake marked as site Twin 1 by the 1854 Treaty Authority (1854 Treaty Authority, 2018). There were small isolated locations of chloride greater than 70 mg/L observed around the perimeter of Little Sandy lake. In general Sandy Lake had lower chloride readings.

# Chloride Transects at the Twin Lakes

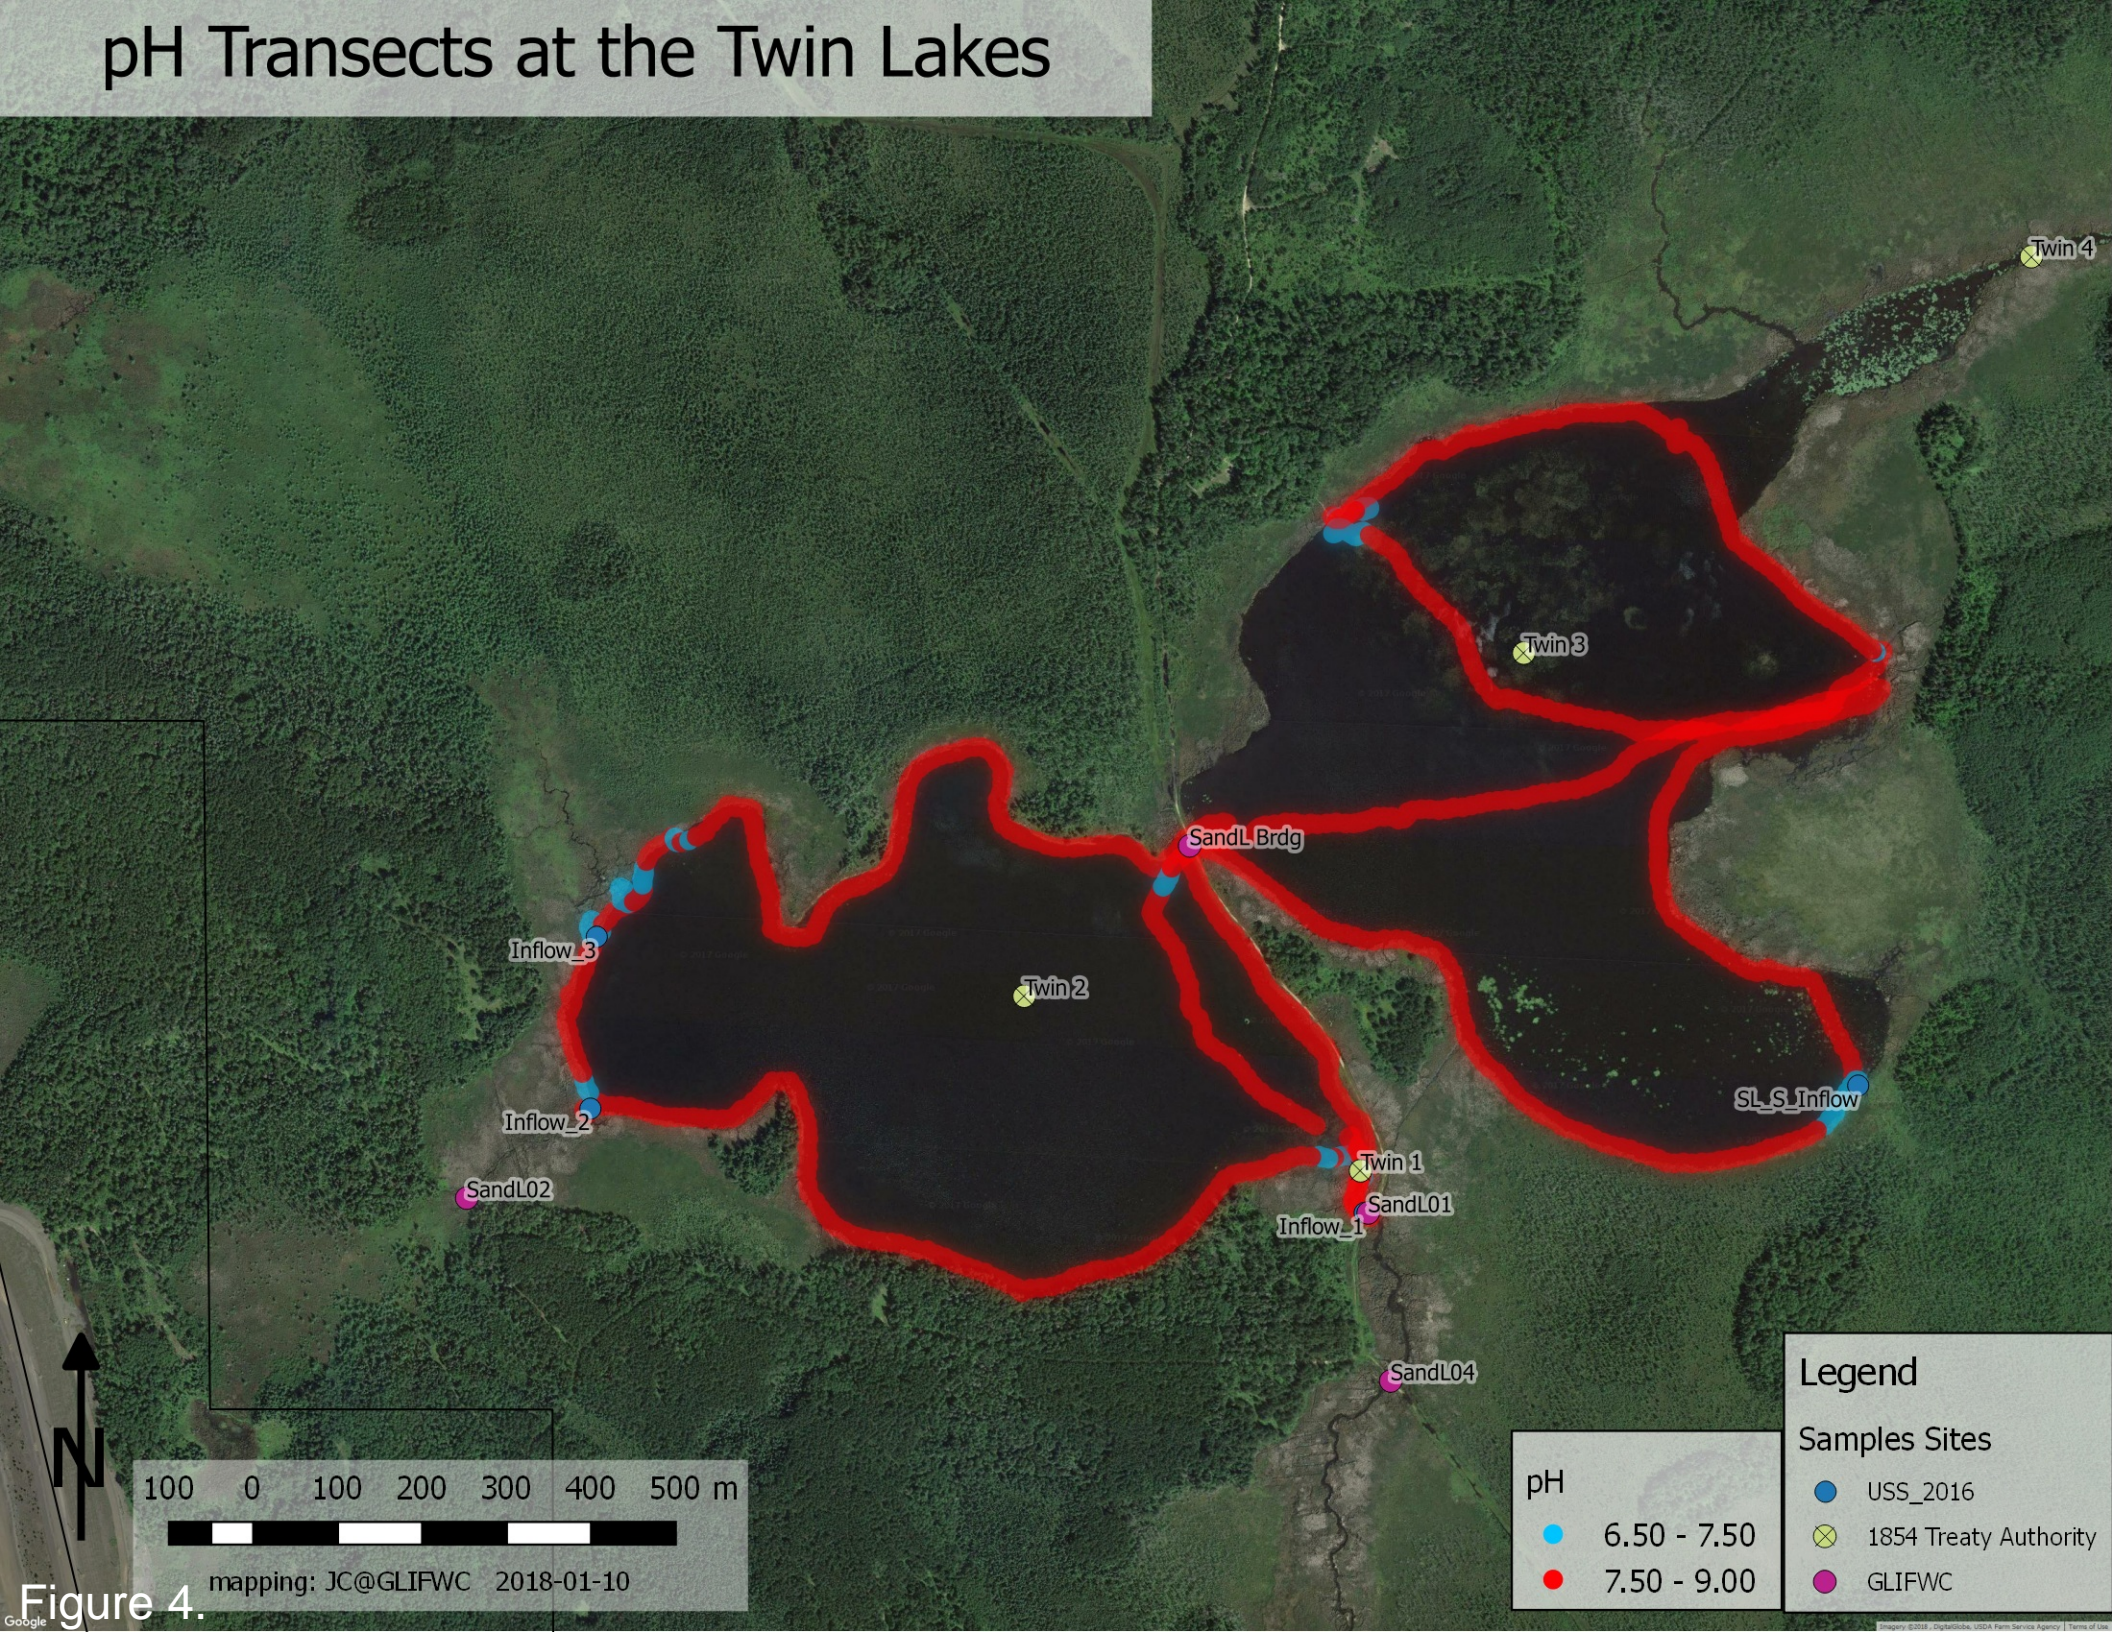
Figure 4.

pH.- pH levels (Figure 4) were generally high in both lakes, despite the lower pH's observed at the inflows to the lakes. Only at known inlets was pH less than 7.5. Exceptions were readings taken in a deeper water zone just to the west of the bridge between the lakes, where pH was below 7.5.

# pH Transects at the Twin Lakes

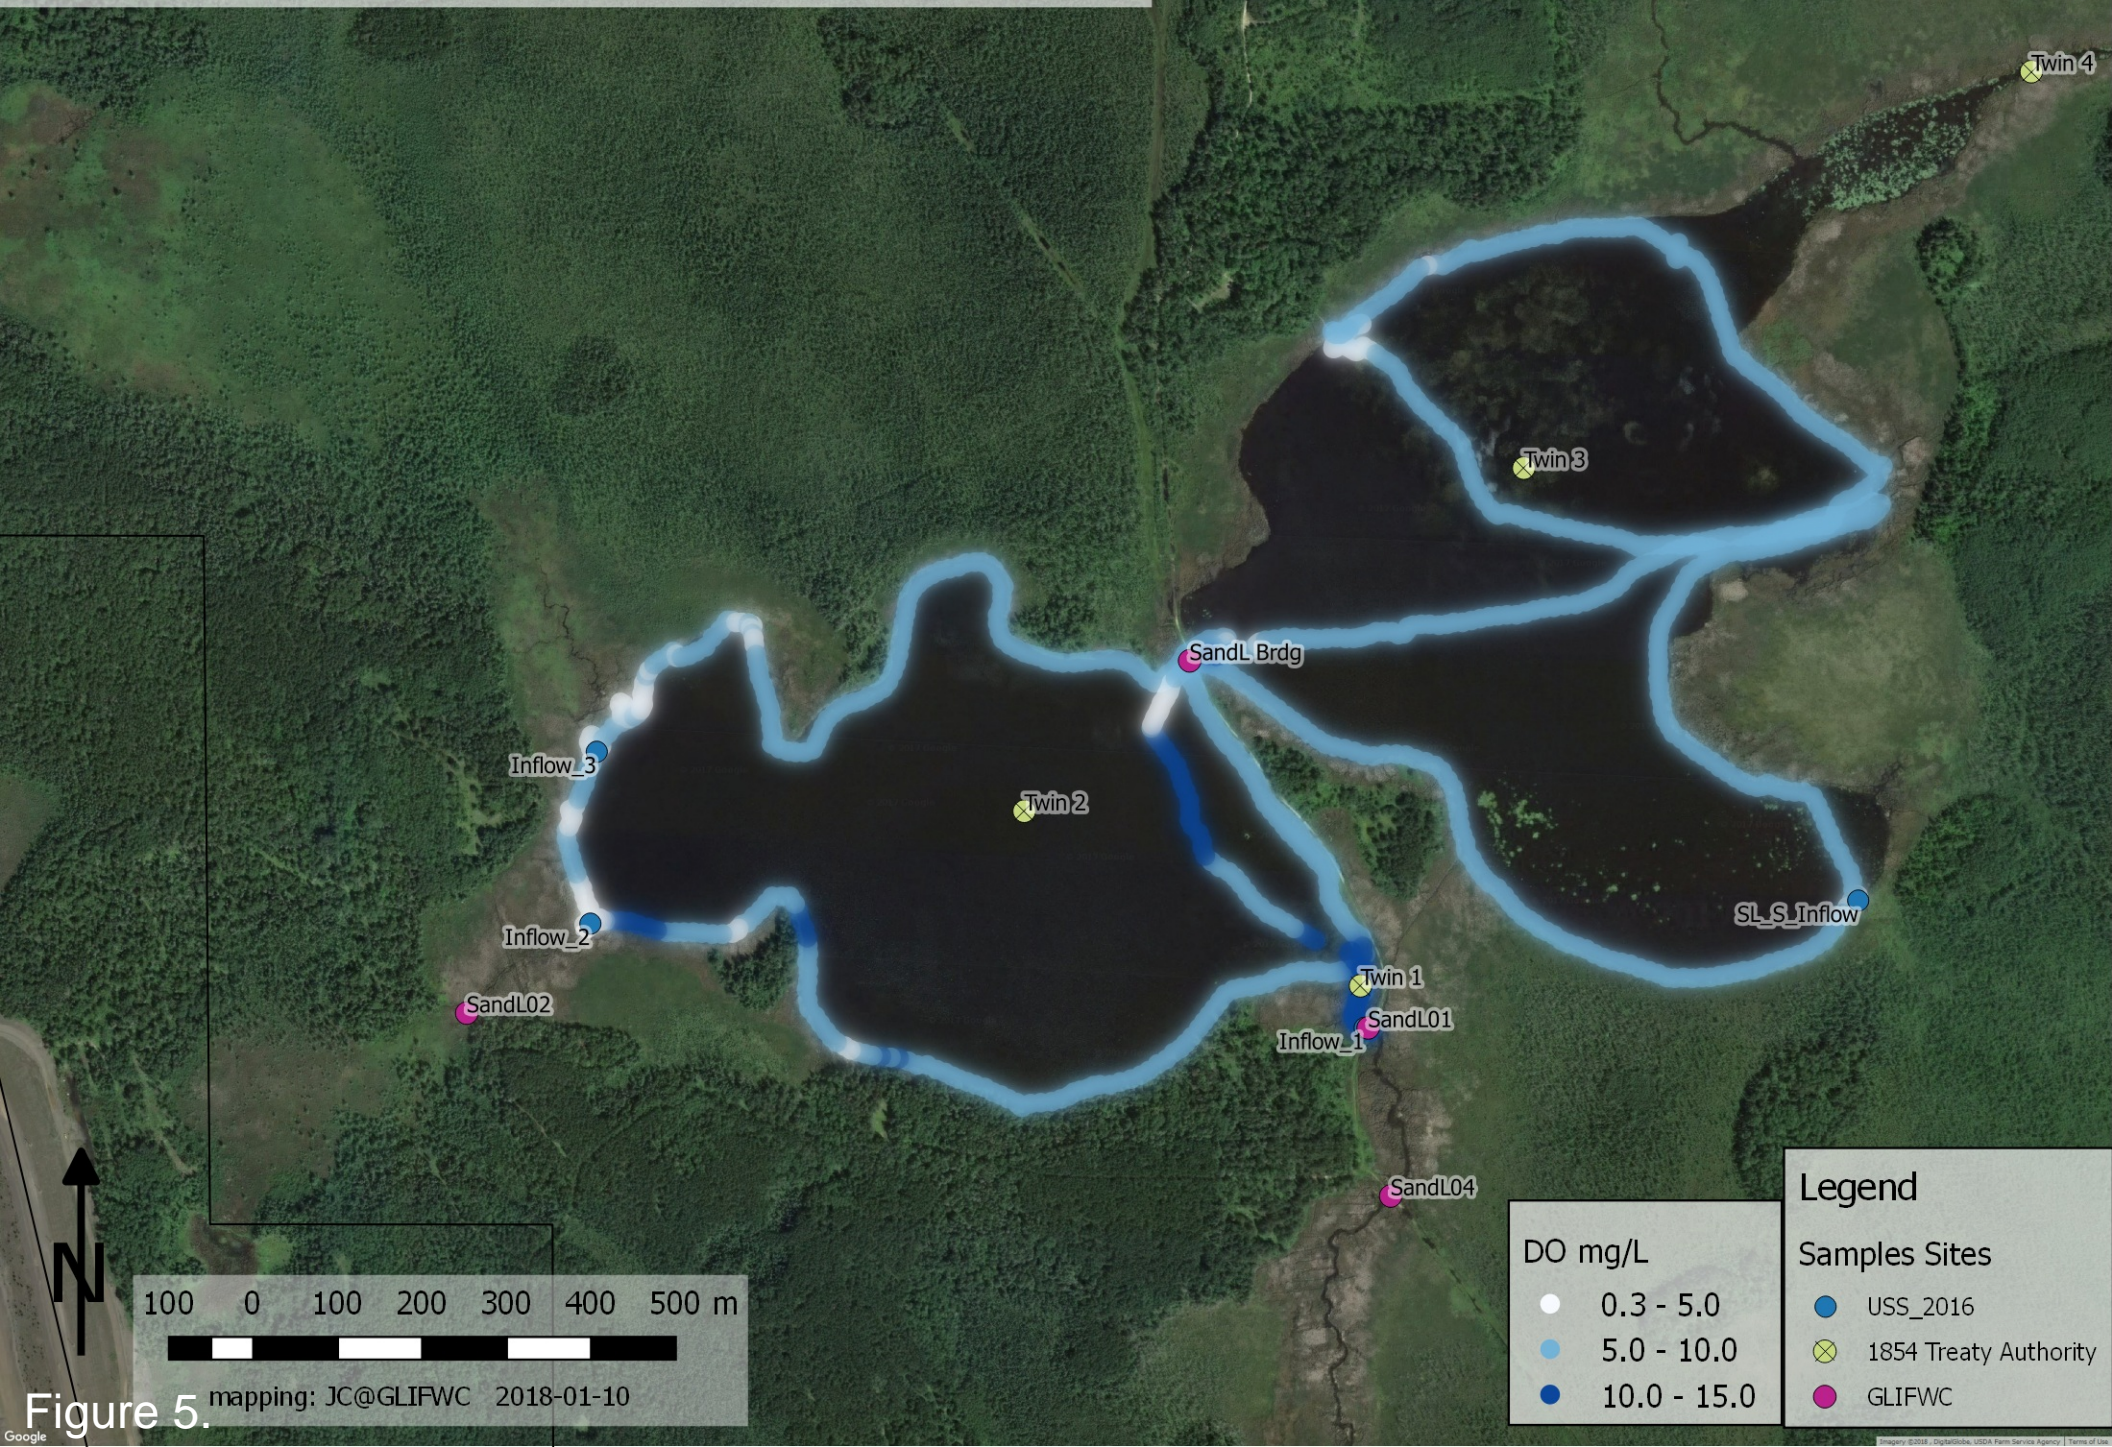
Figure 5.

Dissolved Oxygen.- Dissolved Oxygen (Figure 5) varied in a way similar to pH, with levels above 5 mg/L in both lakes, except near the inlets from cattail marshes to the lakes and the deeper water zone west of the bridge.

# Dissolved Oxygen Transects at the Twin Lakes
